RAF COLTISHALL

A HISTORICAL APPRAISAL

PARTS 10 AND 11

DOMESTIC BUILDINGS, SHQ AND OFFICERS MESS COMPLEX

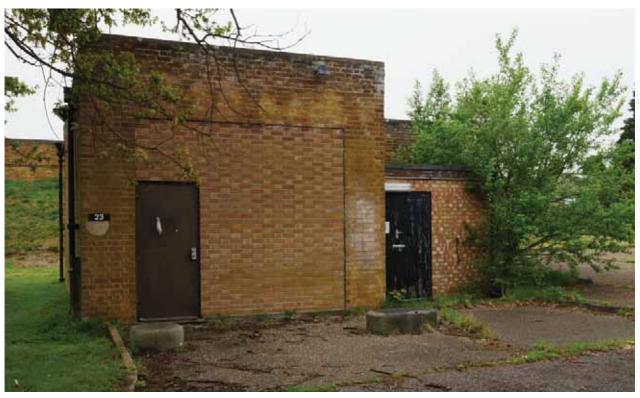
Plate 1: Ambulance shed and mortuary (23), front elevation

Showing the main entrance to both the garage and mortuary bricked up and smaller doors inserted.

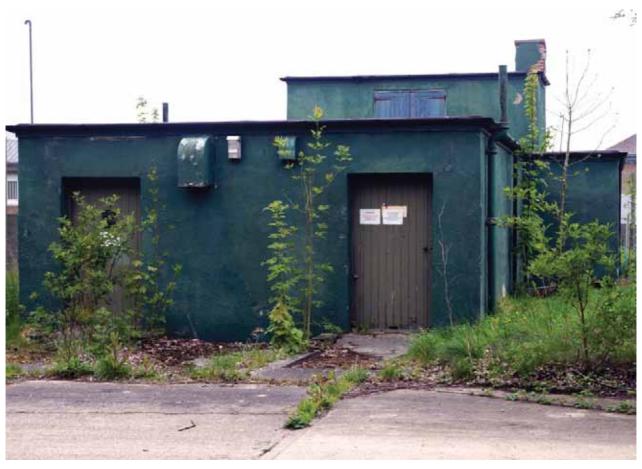
Plate 4: WAAF decontamination centre (29), entrance elevation

The footbath, original doors plus a large and small pressure stabiliser on the end wall can clearly be seen.

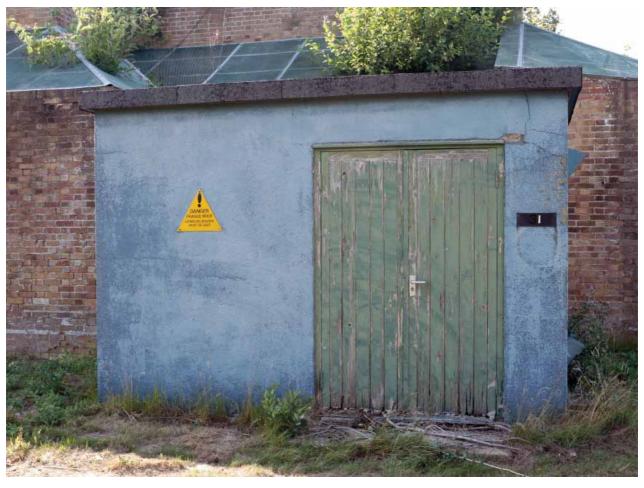
Plate 5: Speech broadcasting house (31)

It is a small single-storey windowless but vented building constructed of 4.5 in cement rendered brick with a felt covered lightweight asbestos deck roof and a single entrance with double doors and a concrete path. There is a single room with a concrete slab floor and a longitudinal concrete plinth to support the amplifiers. Access was not possible.

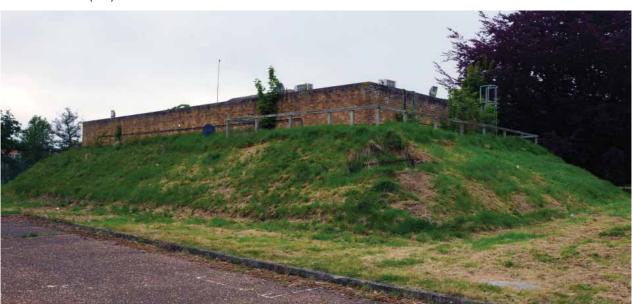
Plate 6: Decontamination centre (32), rear view

The building consists of a windowless single-storey structure with 18 in thick concrete and brick walls protected by earthwork traverses. These along with heavy cased steel beams and internal walls, support a two-tier roof structure. The roof has a one thick-section (12 in) reinforced concrete lower sub-roof and a thin-section (5 in) reinforced concrete upper roof. Separating the two is a composite wall made from 5 in concrete and 4.5 in brick. Cast as part of the lower roof, is a water-tank house containing four 500 gallon tanks directly above the shower room. The cavity between the lower and upper roof is filled with a layer of sand (2 ft 6 in thick) and then a layer of shingle (2 ft thick). So that the tank house has a similar thickness of sand and shingle protection, the centre of the upper roof is carried above the main roof area. It is this hipped-shaped centre section that can be seen prominently above the brick parapet wall which conceals the flat surface of the upper roof. The whole external surface of the roof is covered with asphalt for weather protection.

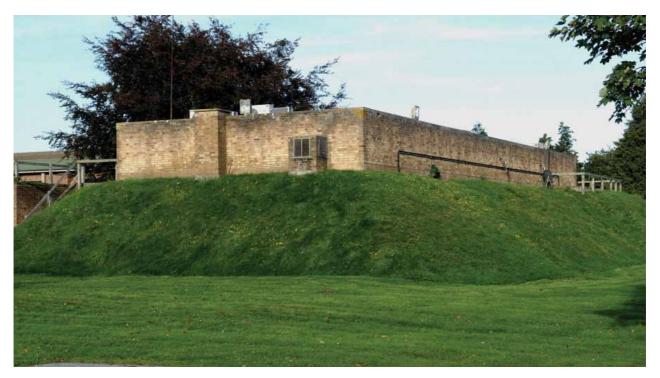
Plate 7: Decontamination centre (32), plant side and rear elevations

The northern side elevation houses the plant and boiler rooms. A motor-driven air filtration unit (with a nominal capacity of 1,300 cfm), supplied clean air via high level metal ducting fixed to a wall of the bleaching and dressing rooms – this equipment is extant in the annexe but is missing from this building. Two pressure stabilisers were located on the wall separating the undressing area with the bleaching room then a second pair was fixed on the outside wall of the reception room. In contrast to this arrangement, the decontamination annexe had exhaust trunking that ran the full length of a side-wall and terminated in the undressing room as a pressure stabiliser.

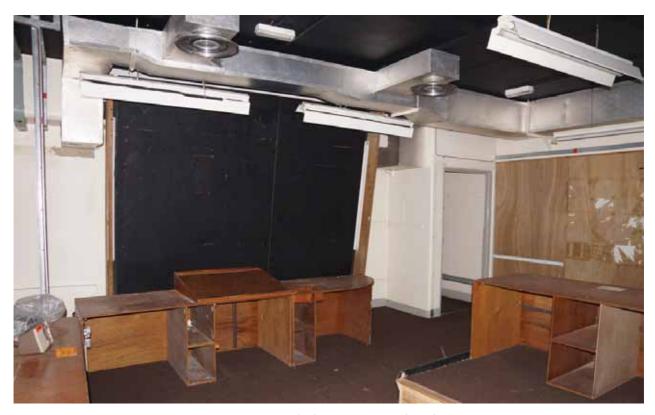
Plate 9: Decontamination centre (32), interior view of the former bleaching room

This was subsequently used as an operations control room

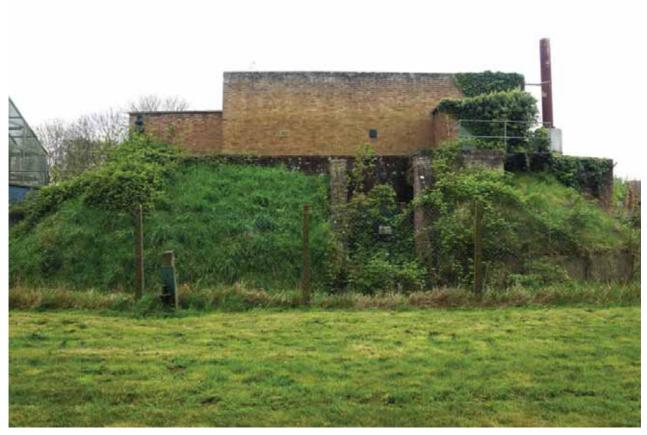
Plate 34: Stand-by set house (58), side elevation showing the modern earthwork traverses

The blast wall, (parts of which have been removed but most of it is extant), is hollow and is filled with sand and shingle. One of the sections that is missing is where the new engine exhaust stack is located and the part over the main entrance. Probably around 1982, earthwork traverses had been built up against the blast walls as part of a series of security measures that were carried out in the UK following the IRA bombing of a barrack block at Uxbridge in 1981.

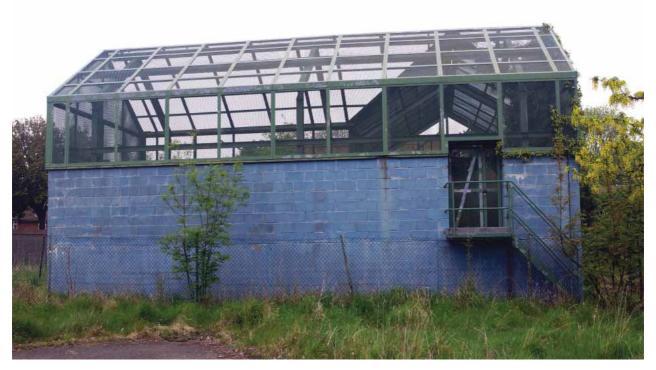
Plate 35: Oil tank bund (112)

After 1952, the existing underground fuel tank was removed and replaced with new tanks installed inside a bunded compound.

After July 1982 a series of security measures were carried out to the diesel fuel installation which included providing a single-storey portal frame over the installation. This was supplied by Bell and Webster and was clad with metal PVC-coated cladding with roof lights. The perimeter bund wall was also extended upwards with lightweight concrete blocks.

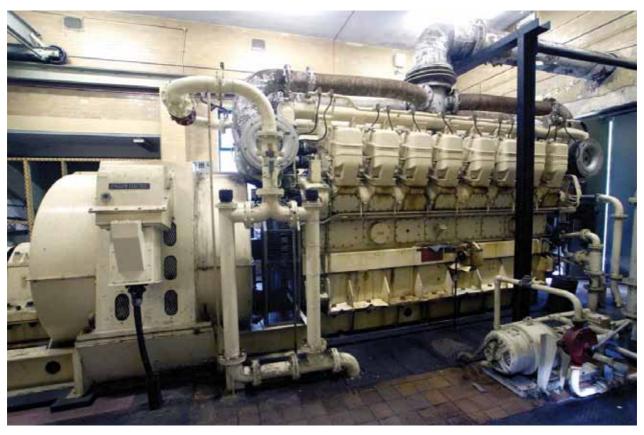
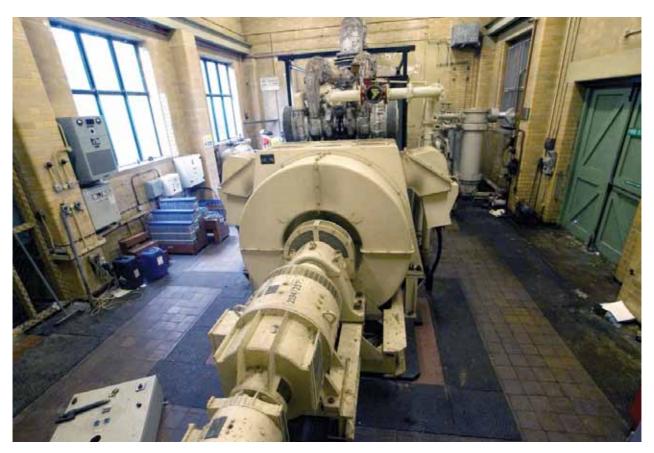
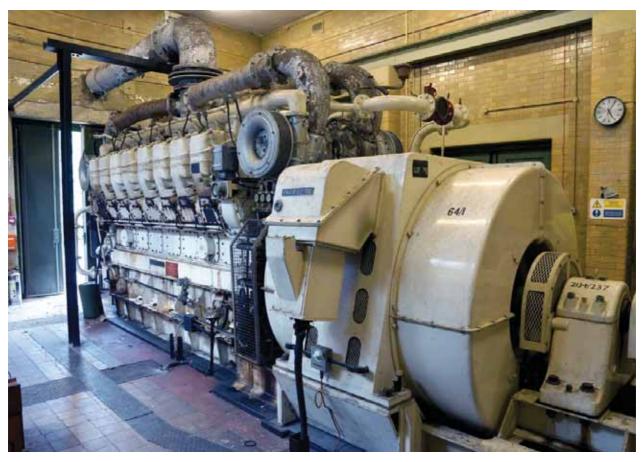
Plate 36: Standby set house (58), English Electric diesel engine

Construction of the main building is of 13.5 in solid brick external walls with internal piers carrying a 3-ton travelling crane, the internal wall finish is salt-glazed bricks. The engine room originally had a concrete platform or mezzanine floor housing a 1,000 gallon cooling tank, but this is now missing. The roof structure is a two-stage protected arrangement with a lower one which is a concrete slab 1 ft thick and an upper one of 6 in concrete slab. The 4 ft 6 in void between these is filled with sand and shingle.

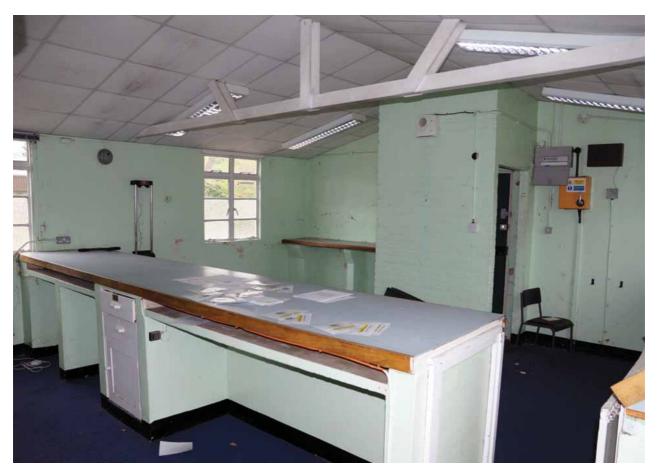
Plate 40: Post Office (65), interior view Looking from behind the counter towards the internal porch. Note the timber truss

It is constructed with cement rendered 4.5 in external walls with external piers and consists of a single entrance with internal porch and a large room subdivided by a concrete counter arrangement. There is a Stephen Cox & Son safe in one corner and a concrete writing bench for customers.

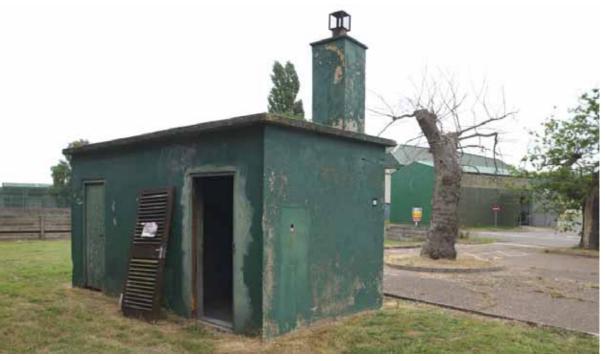
Plate 42: Incinerator building (66), front view

The station incinerator is a small single-storey building, it is constructed of cement rendered 9 in vented brick with one window on the east elevation (which may not be original). It has a 4 in concrete slab roof. There are two entrances (presumably it original had a pair of incinerators) and a modern breeze block dividing wall which divides the building into two equal halves (7 ft 3 in by 8 ft 5 in). A chimney stack is located at the rear as well as a concrete block supports for an oil tank which is missing. Access is not possible to one half.

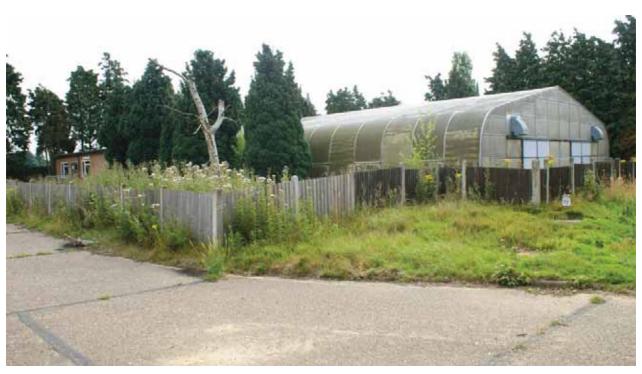
Plate 59: Swimming pool (298), showing GRP cover

The GRP canopy is a clear span arrangement fixed to an aluminium frame; it is only over the swimming pool and sits on top of a dwarf wall.
